AMERICAN SOCIETY OF
ADAPTATION PROFESSIONALS

SNAPSHOT

Enhancing Resilience of Riparian and Wet Meadow Habitats in the Upper Gunnison River Basin

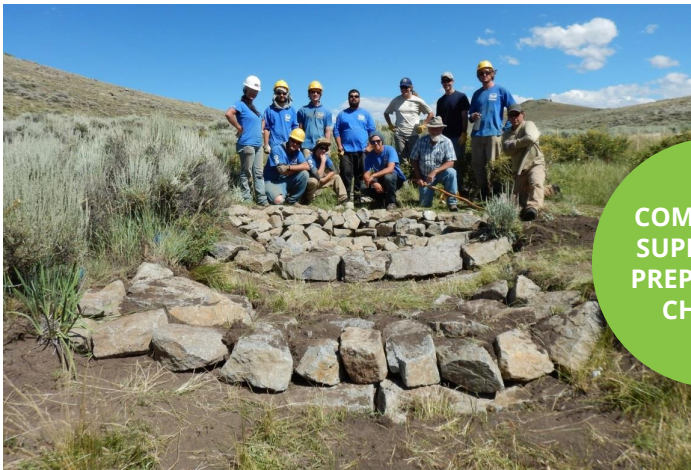
Rock structures

Higher stream
channel

To address these impacts, the Gunnison Climate Working Group implemented innovative yet simple restoration methods, i.e., rock structures, to improve hydrologic and ecological function of the area. The structures work by slowing water passing through the system, resulting in increased sediment deposition behind the rocks/plants and increased height of the stream channel. The higher stream channel reconnects formerly incised channels to the floodplain, increases water retention in stream banks, and reduces erosion. The wet meadow functions are then more resilient in the face of increased warming and extreme climatic events, such as drought and heavy rainfall. Increased resilience to climate change will help the Gunnison sage-grouse adapt to a changing climate by providing habitat during its critical brood-rearing stage.
